## Science of the Total Environment

# Flood characterization based on forensic analysis of bridge collapse using UAV reconnaissance and CFD simulations

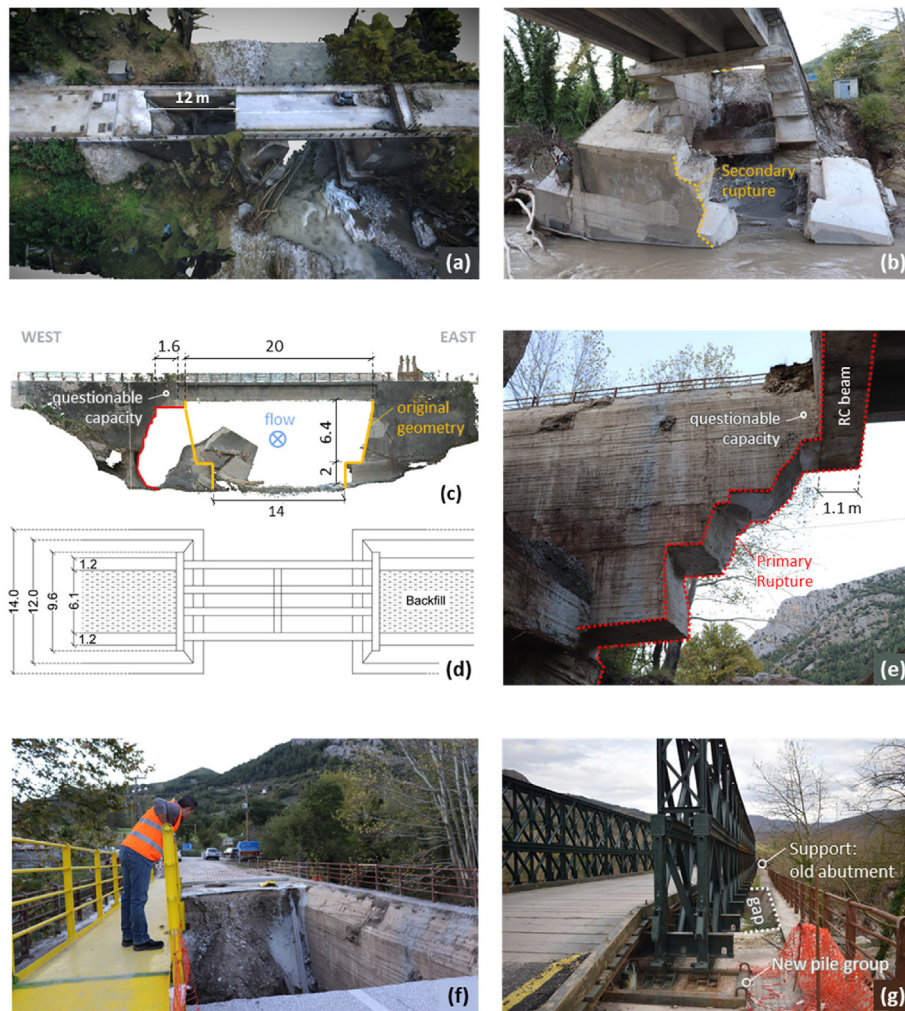
Fig. 4. Bridge 9: (a) 3D mesh model constructed using UAV images; (b) photo of the fractured unreinforced concrete abutment; (c) elevation and (d) plan view; (e) closer view of the failure pattern at the northern (downstream) wall; and (f) photo of the temporary emergency passage on 14 October 2020; and (g) the mitigation solution including the construction of a Bailey bridge on 28 November 2020.

A 12 m long and 8 m wide gap was observed after the flood along the road that connects Mouzaki to Ellinokastro, because of a bridge failure (Fig. 4a–b). The structure was constructed in the 1960s and no drawings or other official information regarding its design are available. Post-flood visual inspections revealed that the bridge consists of (i) a 20 m long deck with a continuous reinforced concrete (RC) slab integrally cast in situ with four precast beams, (ii) three diaphragm beams, one at the mid-span

and two at (iii) the massive abutments. The latter consist of 8 m tall,  $\Pi$ -shaped gravity wingwalls that retain the backfill (Fig. 4c). The wingwalls are made of unreinforced concrete.

Preliminary simulations revealed that modelling of the “weak” zones resulting from the existence of smooth construction joints is essential for the reproduction of the failure plane pictured in Fig. 4e. These construction joints have no reinforcement passing through them and as a result, their response is one of blocks of concrete seating upon each other and relying on friction for the transmission of any lateral loads. Following the model proposed by Clark and Gill (1985), joint planes were associated with a modified Mohr-Coulomb failure criterion with zero tensile strength. Consistently with their recommendation, effective for unreinforced construction joints in concrete prisms with cube strength 24–66 MPa, the characteristic shear strength is calculated as

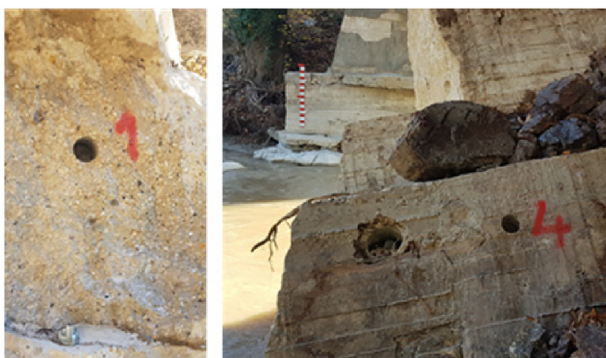
Fig. 6. Photos of core extraction locations.

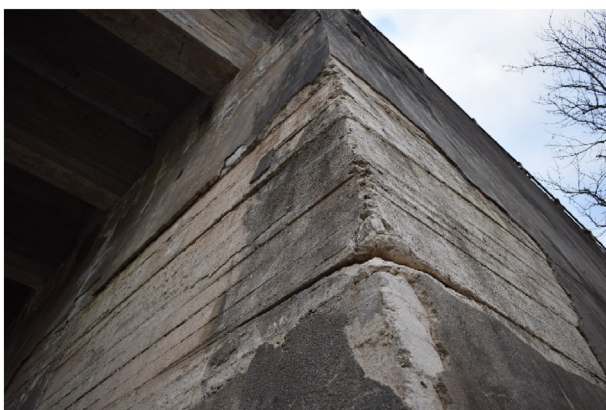
Fig. 9. Photo of the standing, east, abutment with evident relative displacements at the interfaces between concrete blocks, indicating that the joints act as weak zones.
