Landslides Triggered by Medicane Ianos in Greece, September 2020: Rapid Satellite Mapping and Field Survey

Sotiris Valkaniotis, George Papathanassiou, Vassilis Marinos, Charalampos Saroglou, Dimitrios Zekkos, Vasileios Kallimogiannis, Efstratios Karantanellis, Ioannis Farmakis, Georgios Zalachoris, John Manousakis et al.

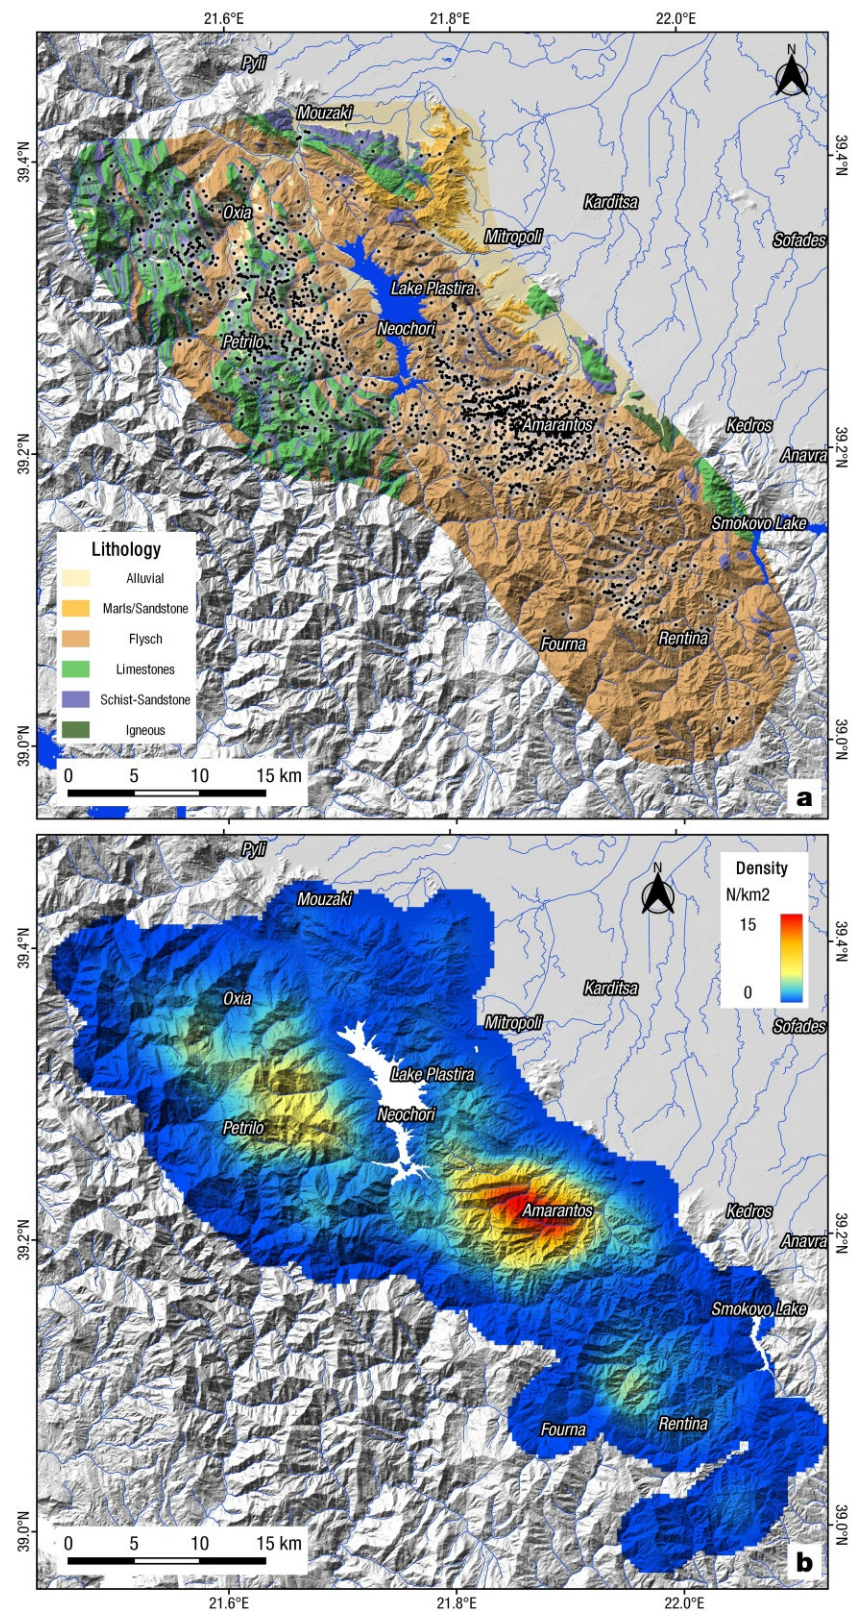
Figure 3. (a) Mapped landslides (black dots) triggered by Medicane Ianos during 17–19 September 2020, and simplified lithology of the area (see text for references). (b) Density map of Ianos landslides (using a radius of 1000 m); two major concentrations of landslides west of Lake Plastira and around Amarantos village.

This preliminary inventory (Figure 3) includes 1697 landslides, limited to a narrow mountainous area of Karditsa and part of Evritania regions. Examination of Sentinel-2 imagery over the Pindos mountain region showed no or few sparse landslides, outside this area. The largest concentration of landslides was found around Amarantos village, southeast of Plastira lake, with up to 15 landslides per square kilometer (Figure 3).

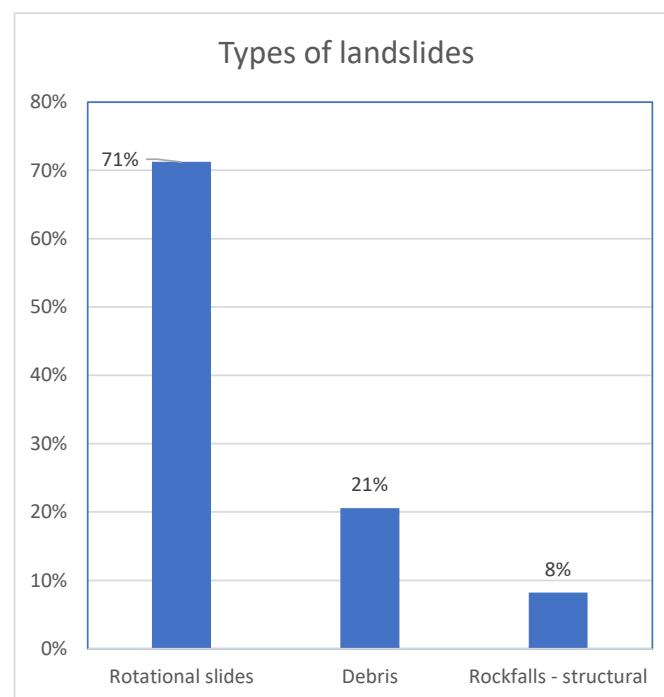
Figure 5. Types of landslides identified in the field reconnaissance surveys.

Based on the information obtained, the majority of landslides are classified as rotational (Figures 5 and 6), causing the most severe damage to the human-made environment in the wider investigated area. As it has been previously mentioned, these slides occurred mainly in the weathered flysch mantle and the siltstone flysch formation, due to their overall low rock mass strength.

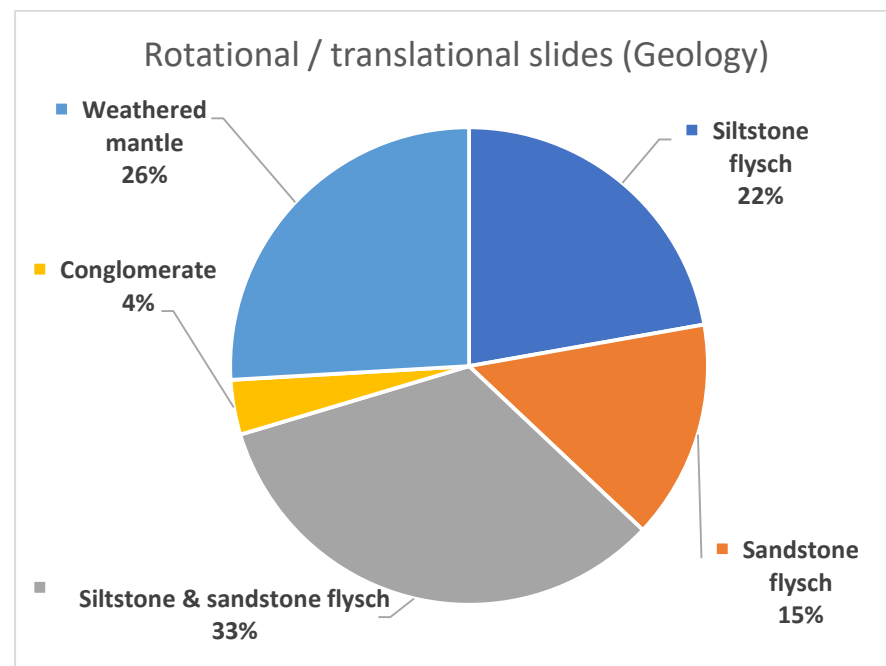
Figure 6. Different lithology types affected by rotational and translational slides.

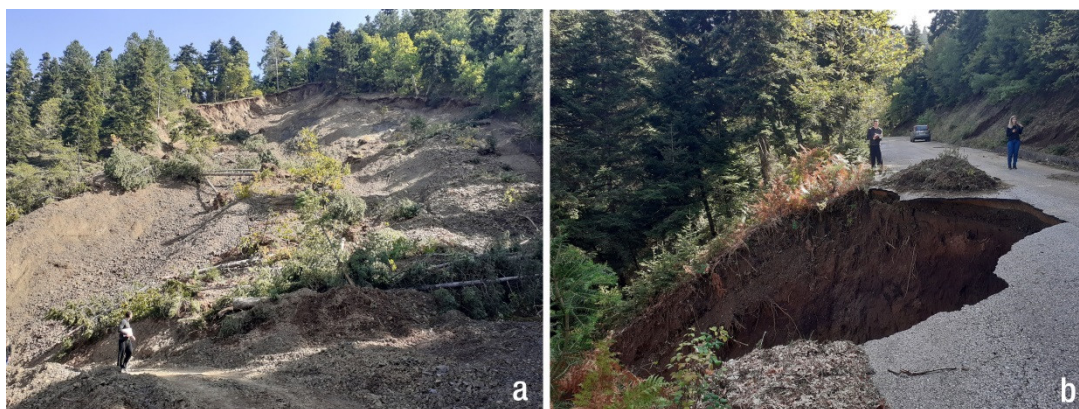
The most severe landslide-induced failures in Karditsa Prefecture were around Amarantos village, located to the south-east of Plastira lake. In Figure 7a, a landslide that occurred in siltstone flysch causing the road failure is shown. In particular, the road was totally covered by slipped material across a length of 200 m, while its depth was estimated at about 15 m. Its height is approximately 70 m. The slide failure plane was probably constrained by the presence of a deeper stronger flysch layer downslope. In Figure 7b, a rotational slide in the weathered mantle of siltstone flysch is also shown. This landslide resulted in the collapse of the road pavement for a length of 10 m.

Figure 7. Characteristic rotational failures around Amarantos area. (a) large failure in siltstone flysch west of Itamos village and (b) failure in weathered flysch mantle material causing damage to the road.

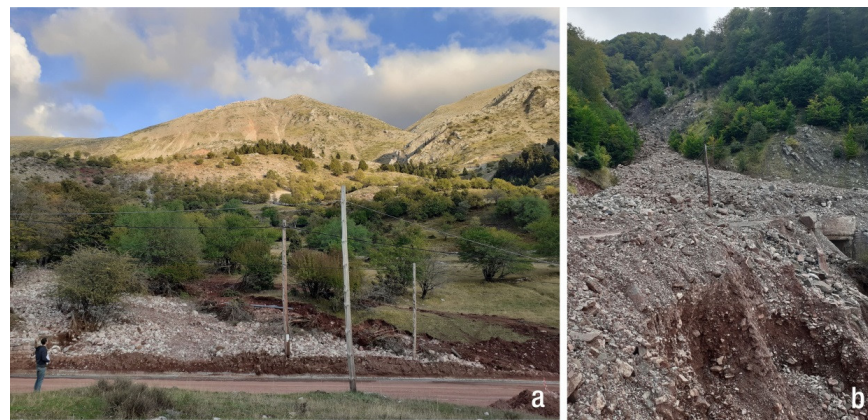
Extensive debris flows were mapped in Livadia and between the communities of Pefkofito and Vlassi (Figure 8). Specifically, the thickness of the debris at the road level is

5 m while the impacted area is 300 m long in the former case. The debris flow material mainly consisted of limestone fragments and clay materials (Figure 8a).

Figure 8. (a) Characteristic debris flow at Livadia village; (b) extensive debris flows in gullies in the area between Pefkofito and Vlassi.

Regarding the second case, located in the area between Pefkofito and Vlassi (Figure 8b), it should be pointed out that this area is characterized by steep morphology while the extensive amounts of debris have been transported via deep gullies from higher elevations.

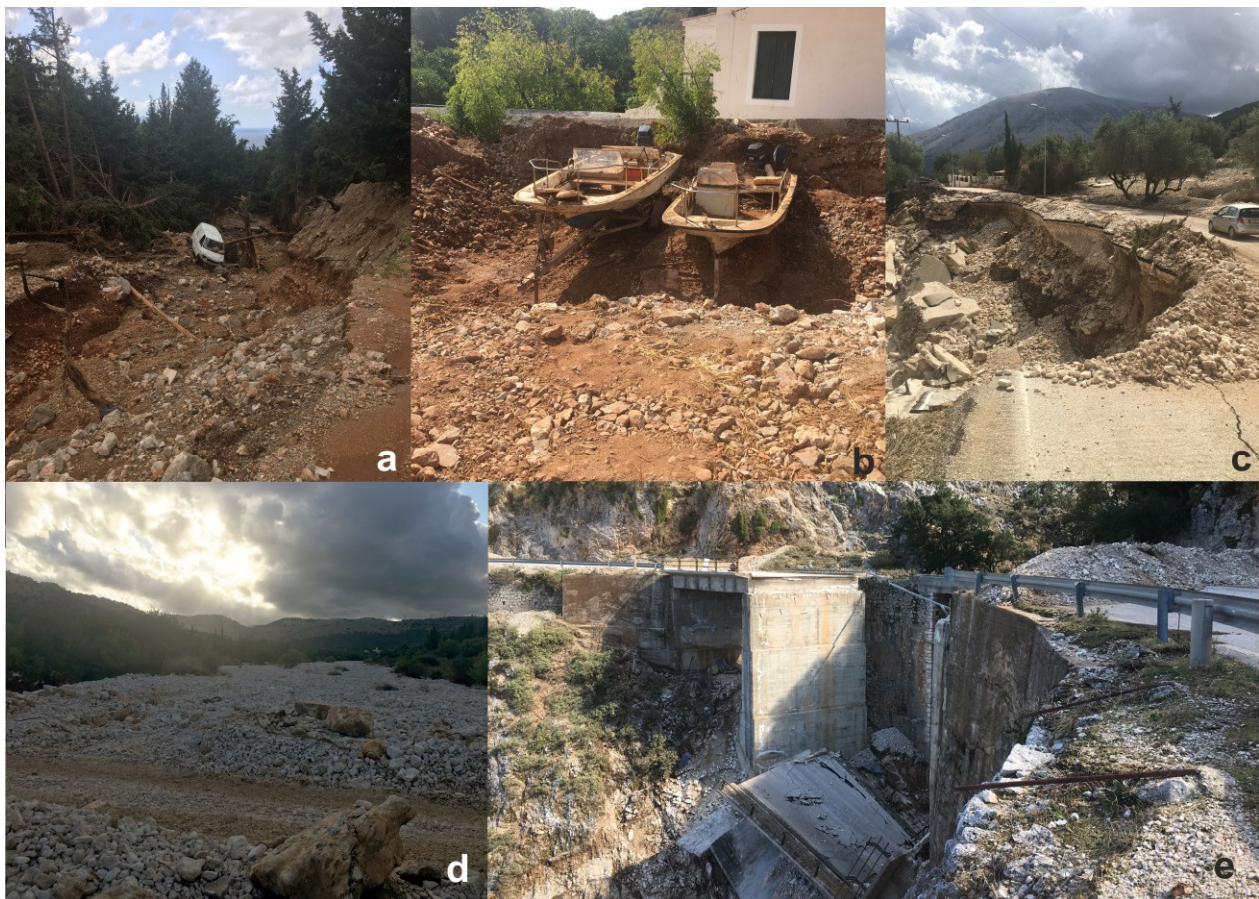
Cephalonia Island was heavily impacted by Medicane Ianos. Ianos was the most damaging natural hazard event for Cephalonia island, since the earthquakes of 2014 that caused building damages, widespread landslides, rockfalls and liquefaction over the island [38–41]. Severe rainfall at Cephalonia peaked at 759 mm (17–18 September 2020) during the passing of Medicane Ianos from the Ionian Sea islands [12]. In particular, the highest severity of the Medicane-induced phenomena was reported at the northern-central part of the island towards Erissos peninsula, between Sami and Fiskardo. Debris flows and landslides occurred in several locations across the island (Figures 10 and 11). Often the debris flows covered wide areas (~40–70 m in width), while typically the average size

of debris blocks reached 20–50 cm (Figure 11d). Moreover, the earth flows were often associated with road embankment failures (Figure 11c). The latter was also observed in cases of severe riverbank erosion/scour. The road network of the island was damaged and/or obstructed in several locations due to landslides, while a critical simple-span reinforced concrete bridge near the village of Agkonas collapsed due to scour of the west pier foundation by extensive gully flooding and debris (Figure 11e), heavily impacting the transportation network of the island.

Figure 11. Characteristic damages in Cephalonia Island following Medicane Ianos: (a) Riverbank erosion, (b) debris flow within a rural community, (c) road embankment failure, (d) extensive debris flow, and (e) bridge collapse.

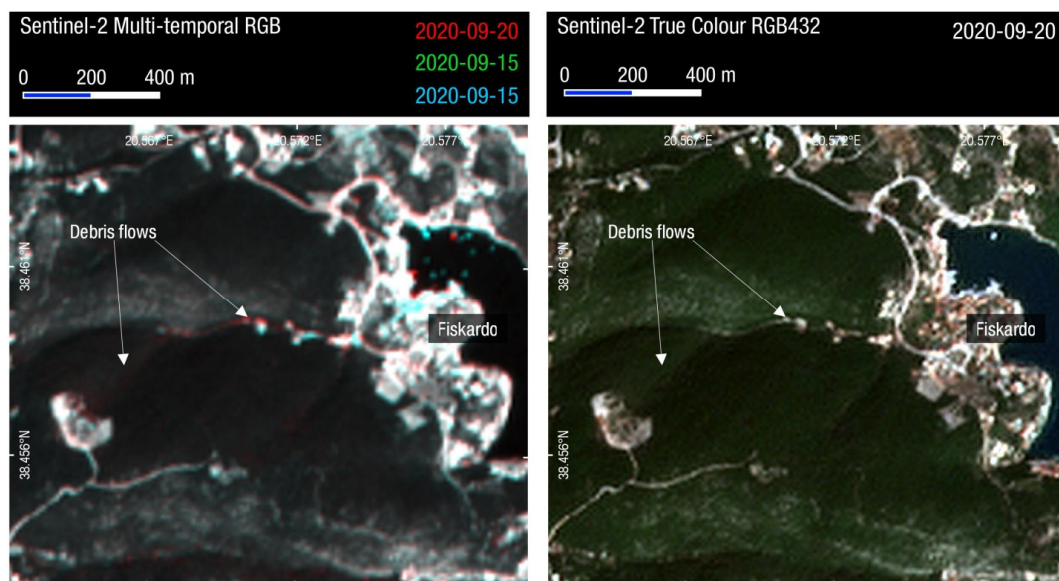
Figure 13. (Left): Sentinel-2 multi-temporal composite (Band 4) Fiskardo, Cephalonia. (Right): Sentinel-2 true color composite (Bands 4-3-2). Red colors mark the location of debris flows upstream of Fiskardo.

Similar to Assos, just outside of the village of Fiskardo (Figure 13), which is situated at the northern part of Erissos peninsula, a debris flow was documented. The debris flow had a lesser extent than the one that occurred in Assos, but was still significant, with the flow reaching a run-out distance of approximately 400 m. Significant erosion features were observed near the source of the debris flow. Eroded zones reached, at places, a depth of 2 m. The debris flow is also visible in Sentinel-2 satellite imagery, as shown in the pre-and-post-event images (Figure 13). Moreover, several rotational landslides were identified along the steep central coastline, particularly near Myrtos beach. Sentinel-2 pre-and-post event images of landslides and debris flows near Myrtos beach, and the collapsed bridge at Agkonas village are shown in Figure 14.

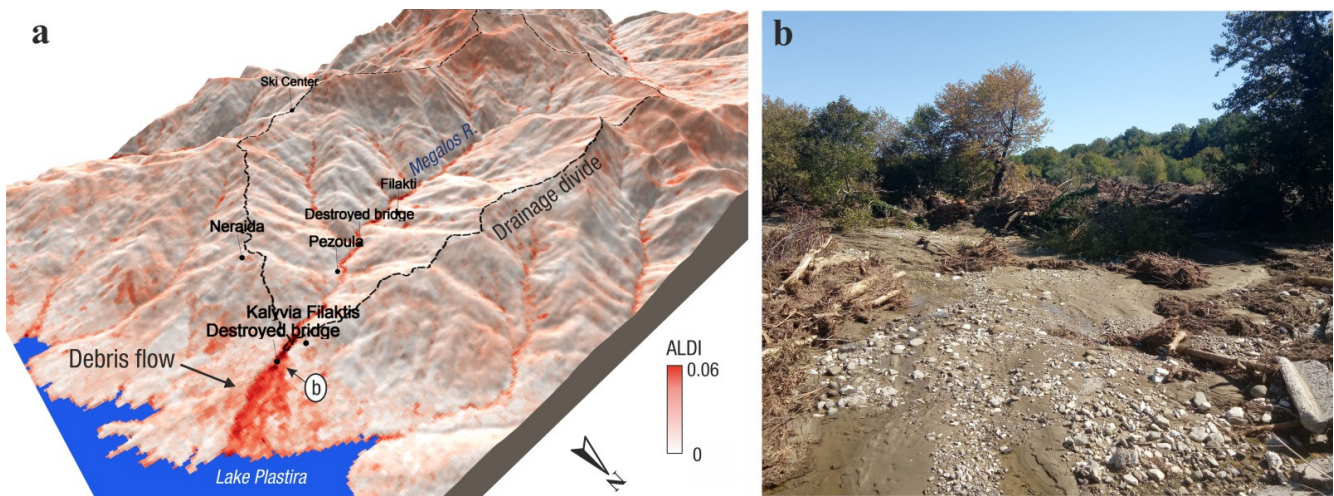
Figure 16. Debris flow and landslides along Megalos River in Filakti/Pezoula area (a). 3D view of the Megalos River watershed with debris flows along the main river course and its exit to Lake Plastira (red colors of ALDI change detection index values). Flooding, severe sedimentation and material transportation from upstream was mapped at its exit (photo (b), view towards east with location marked in (a)) and near Pezoula. Road bridges were destroyed in both locations, with positions labeled in (a).
